Manhole Inspection Summary

Manhole # S53I__011MH

Insp Date: **4/10/08 3:15 PM**

Location Address: **503 bouldin**

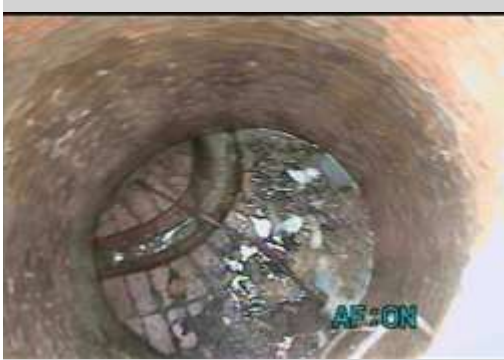
Defect 1

Condition: ☐ Sound ☐ Cracked ☐ Root Intrusion ☐ Deteriorated ☐ Leaks ☒ **Debris**

Steps Count: **4** Missing: **0** ☒ **Corroded**

corroded steps; bench and channel debris

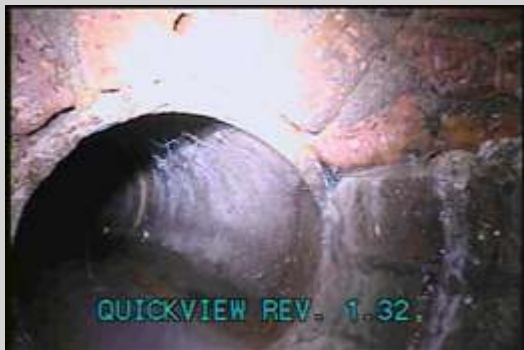
12 O'Clock Outflow

8 in. Circular Gravity Sewer
Pipe Out @ 12 O'Clock

Invert Depth: **9.46** (ft.) Flow Characteristics: **Slow**

Infiltration: **None** Pipe Seal Cond: **Unknown**

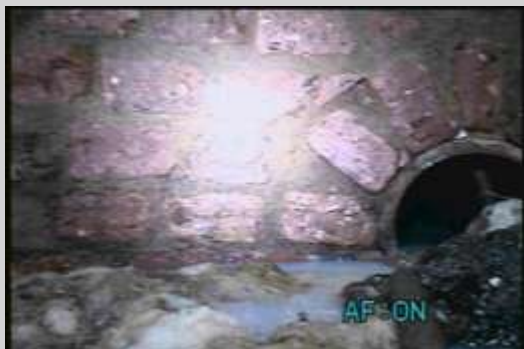
5 O'Clock Inflow

8 in. Circular Gravity Sewer
Pipe In @ 5 O'Clock

Invert Depth: **8.80** (ft.) Flow Characteristics: **Slow**

Infiltration: **None** Pipe Seal Cond: **Unknown**

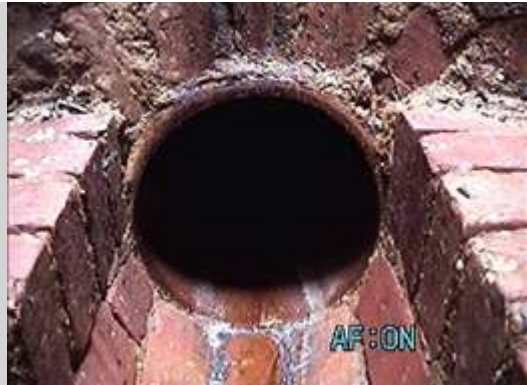
9 O'Clock Inflow

8 in. Circular Gravity Sewer

Pipe In @ 9 O'Clock

Invert Depth: **9.10** (ft.) Flow Characteristics: **Slow**

Infiltration: **None** Pipe Seal Cond: **Unknown**
